Phase I Environmental Site Assessment  
 Lomas Encantadas 1A-1G, 2A-2D, 2F  
 Camino Encantadas  
 Rio Rancho, Sandoval County, New Mexico

Zia Project No.: NALE-16-004 (200)

Date: January 16, 2016

## Site Photographic Log

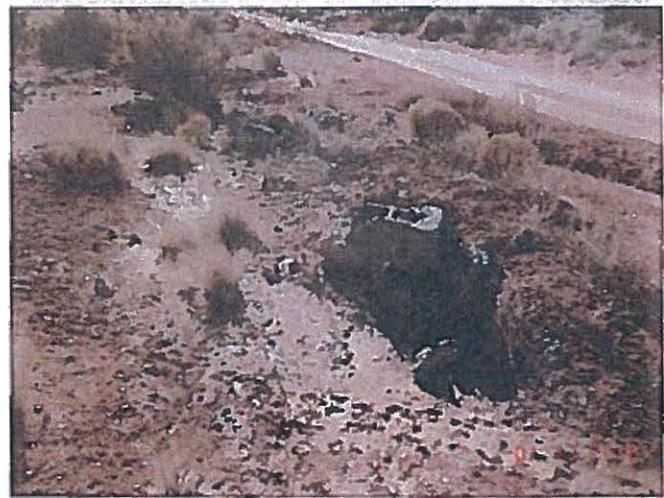
Photo 6: Surface debris in the west portion of Unit 1-B.

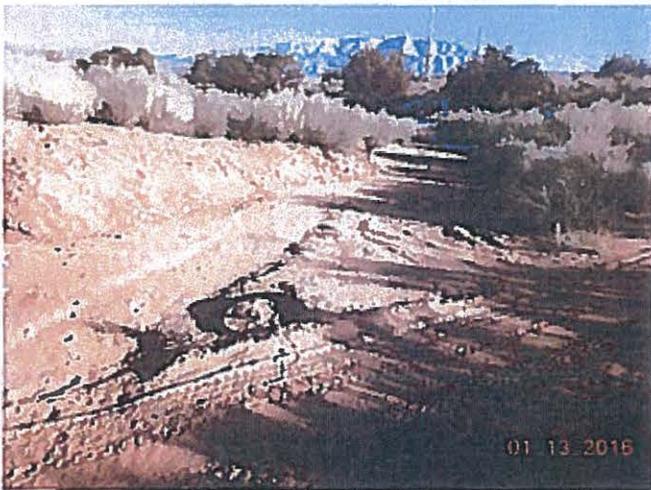
Photo 27: Tires in the south portion of Unit 1-G.

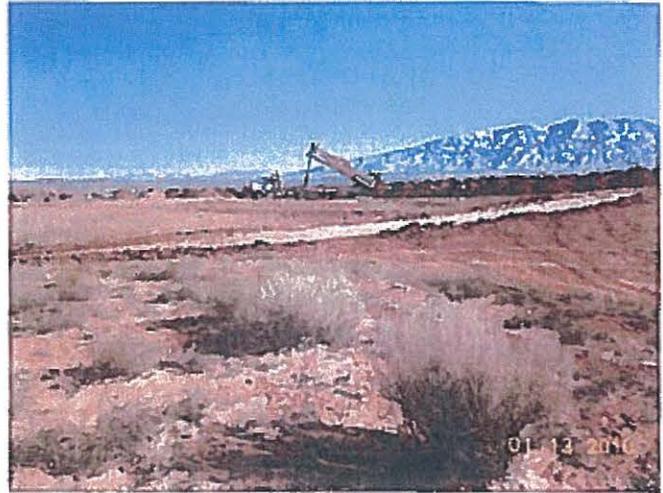
Photo 34: Earth moving in process in the northwest portion of Unit 2-B.

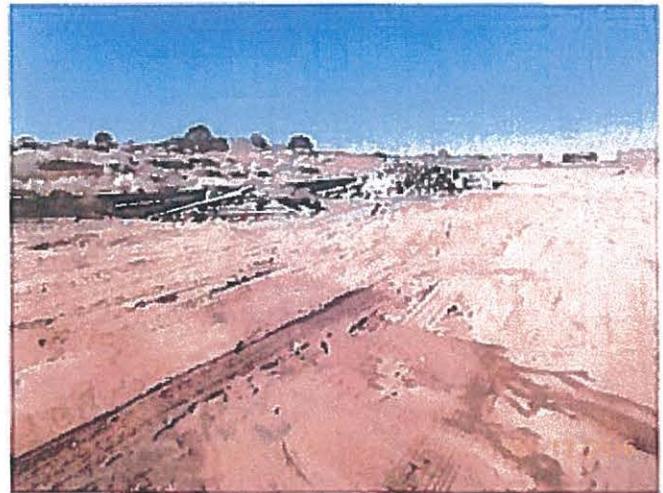
Photo 35: Construction debris pile in the northeast portion of Unit 2-B.
