PHASE I ENVIRONMENTAL SITE ASSESSMENT

ENCHANTED HILLS UNIT 11B
U.S. HIGHWAY 550
RIO RANCHO, SANDOVAL COUNTY,
NEW MEXICO 87144

January 2016

Zia Project No. NALE-16-004 (100)
Zia Document No. NALE-16-004 (100)-16-340
Submission Date: January 25, 2016

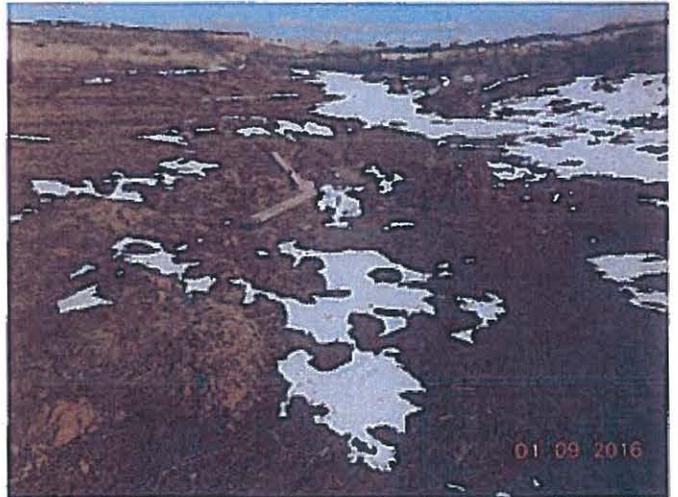
Several small areas of surface debris were observed during the site visit. Based on visual observations (surface materials only), a radiator was observed along the west side of the site, north of the storm water ponding area. Some wood, cardboard, and bales of hay were observed within the northwest storm water ponding area. A wood pallet is located in the southwest corner of the subject property. Some concrete debris and minor quantities of other debris were observed along the east block walls.

Photo 12: Minor surface debris in the northwest storm water retention basin

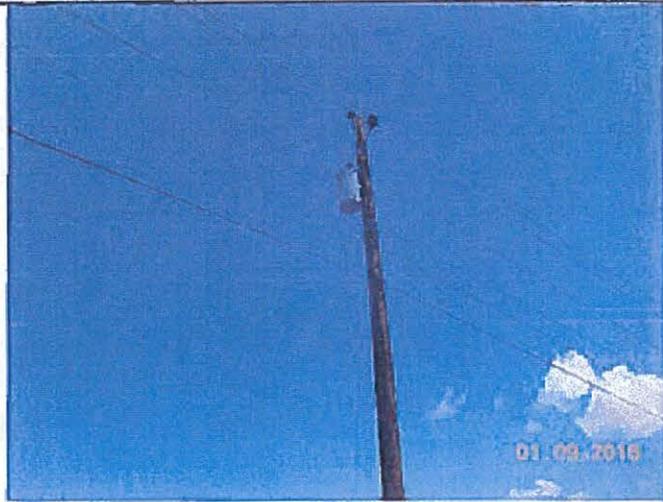
PNM maintains responsibility for the transformers, and if the transformers were "PCB" contaminated, the utility company is not required to replace the transformer fluids until a release is identified. However, no evidence of current or past releases was observed in the vicinity of the electrical equipment during the site reconnaissance.

Photo 13: PNM pole-mount transformer located near the north-central portion of the site

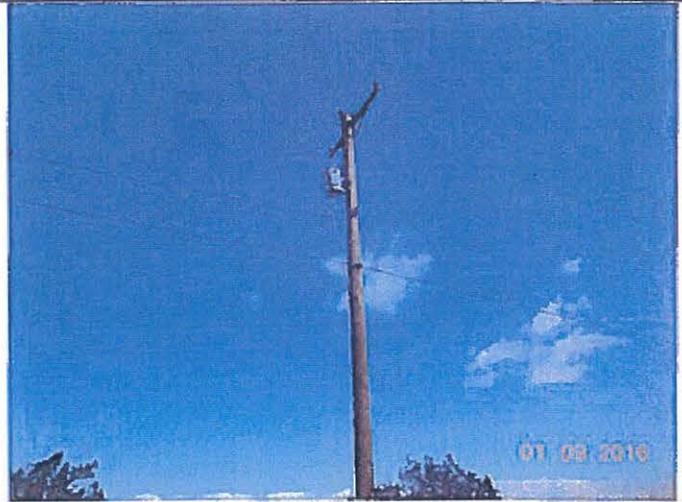
Photo 16: PNM pole-mount transformer (Station No. 1884) located near the northeast corner of the site
